**POWER PLANTS AND THE MARINE ENVIRONMENT  
ADDITIONAL OBSERVATIONS  
IN PITI BAY AND PITI CHANNEL, GUAM**

**Technical Report No. 21**

**July 1975**

GUAM POWER AUTHORITY

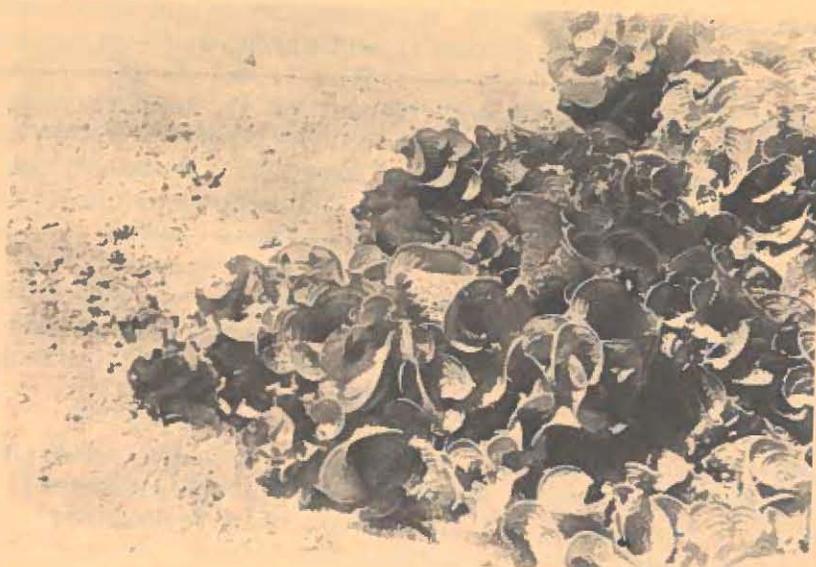
Figure 13. Padina tenuis in Upper Piti Channel.

Results are presented in Fig. 12. The area immediately adjacent to the outfalls of the Piti Power Plant is characterized by two dominant algae within the first 100 m. These are the red alga Gracilaria salicornia (Mert.) Grev. and the brown alga Padina tenuis Bory which have been observed to be the dominant forms here ever since these studies began. Gracilaria forms large clumps which may be up to 20 cm high and 1 m across. These were estimated to cover approximately 3% of the total substrate area in the region of highly agitated water immediately adjacent to the outfalls. Padina (Fig. 13) was estimated to cover between 40 and 75% of the total available substrate, being denser at distances greater than 50 m from the outfall pipes than immediately adjacent to these pipes. Padina was sometimes found growing on Gracilaria. Neither of these species of algae is unique to the outfall area, both being found farther downstream in the channel and widely distributed on the tidal flats. However, their density is greater in the outfall area than in other parts of Piti Channel or the adjacent tidal flat areas. Many other organisms are common in this area but did not show up on our transect. These are listed in Table 1. We have found no organisms which are unique to the outfall area alone. Water turbulence in this region is high and the loose substrate is composed of large-grained sand and rocks, since finer material is swept away by the current.

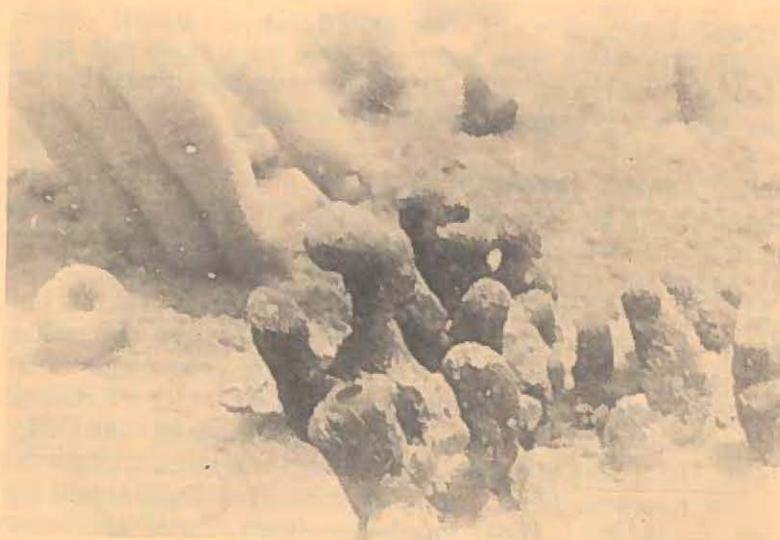
Figure 14. Spirastrella vagabunda in Upper Piti Channel.

Another organism characteristic of practically the entire length of Piti Channel, with the exception of the first 250 m immediately downstream of the Piti Power Plant outfalls, is the brown-colored sponge Spirastrella vagabunda (Ridley). This sponge (Fig. 14) may grow individually or in colonies and has a patchy distribution, so that aggregations of many individuals or colonies are interspersed in areas of similar sandy bottom which are relatively barren. (This patchy distribution is similarly characteristic of most of the other organisms discussed here and introduces a great deal of variability into counts of organisms intersecting the transect line or occurring in the quadrats.) This organism has not been found in the area traversed by Tr 1 and 2, and only an occasional individual has been found in the area represented by Tr 3. More were found in the vicinity of Tr 4 but not directly on the transect itself. Sponge patches were quantitatively estimated to occupy 14% of the area along Tr 5, where they first became abundant. This increased to 17%, 16%, and 30% for Tr 6, 7, and 8 respectively, although on Tr 8 the sponge was concentrated in the first 70 m and did not occur in the last 30 m. This was followed by the absence of the

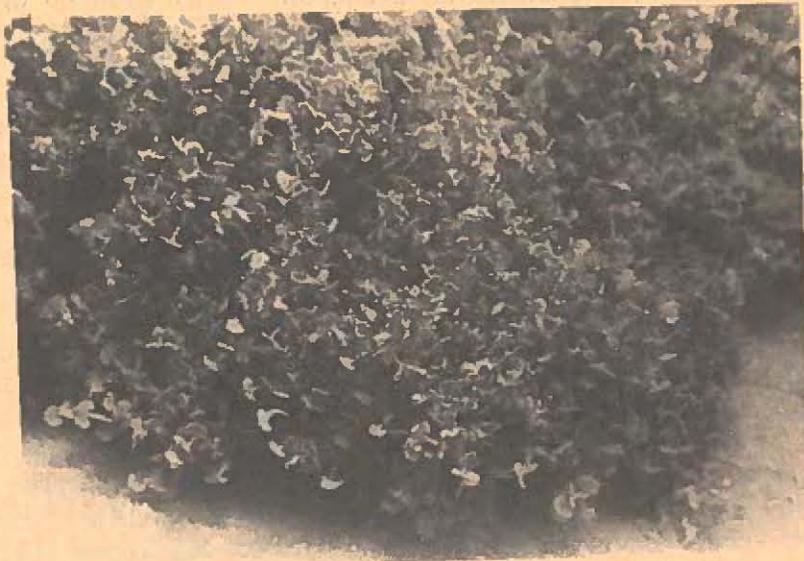
Figure 15. Halimeda opuntia in Lower Piti Channel.

One other prominent biological feature found along the length of Piti Channel is the presence of large clumps of the green alga Halimeda opuntia (L.) Lamx. and to a lesser extent of the related species Halimeda macroloba Decaisne. H. opuntia (Fig. 15) forms dense clumps which may be as much as 2 m across and as much as half a meter high. The clumps are dense enough to form a distinct micro-habitat for other organisms, which in fact are often found associated with the Halimeda beds. The Halimeda clumps can be found in the vicinity of the outfall pipes and extending downstream all the way to the west end of Piti Channel. They are smaller (less than 1 m across) and sparser in the outfall lagoon and increase in size and frequency progressively down Piti Channel, having the largest size and greatest abundance in Lower Piti Channel. Even though present in the area above this, the clumps did not appear on our transects until Tr 6. They covered very little of the substrate in Tr 6-11. Such clumps then covered 6.4%, and approximately 3% of the area along Tr 12 and 13, respectively. Bottom coverage peaked in Tr 14, with 17.5% coverage along that segment. This

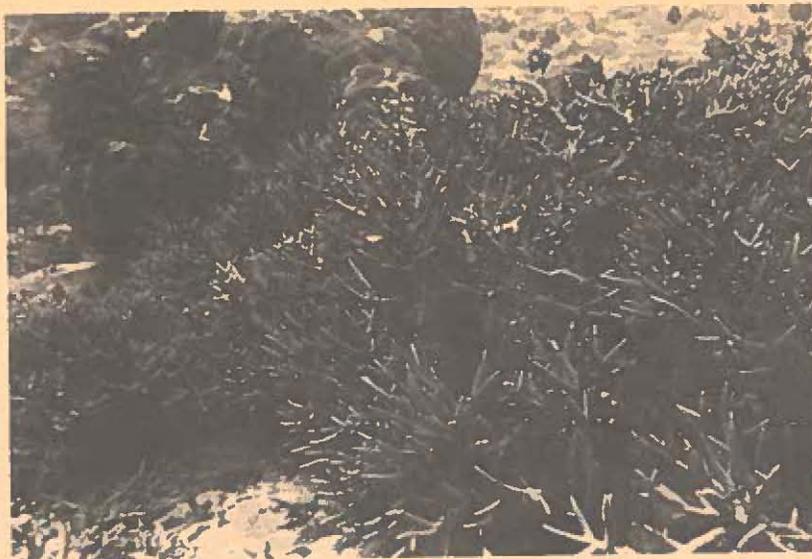
Figure 18. Live Acropora in an undamaged area of the reef in West Piti Bay.

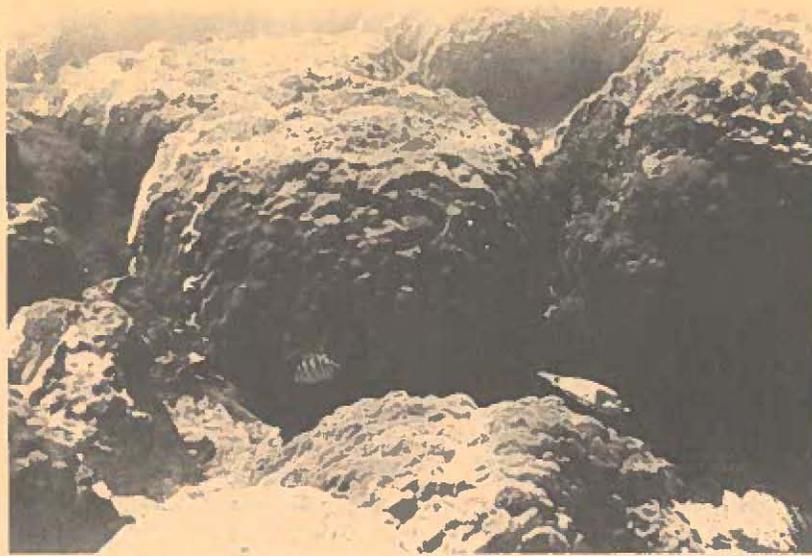
Figure 20. Live Porites heads in an undamaged area of the reef in West Piti Bay.

The remaining live coral zone (Fig. 17) is in marked contrast to the damaged area. Large heads (up to 1 m diameter) of the massive coral Porites constitute the dominant form. Areas of sandy bottom are interspersed between these heads. They are analogous to the trees in the forest which provide a characteristic three-dimensional habitat. It was the removal of such habitat that so markedly altered the character of the bulldozed area. In adjacent areas with somewhat higher reef-flat elevations, there is a dominance by the staghorn coral Acropora. At least 75% of this was killed by extremely low tides and falling sea level during the late months of 1972, but it was still standing in place and providing habitat for other organisms at the time of the dredging and bulldozer destruction. A number of
