EPA-600/3-76-027

BIOLOGICAL IMPACT CAUSED BY CHANGES ON A TROPICAL REEF

Robert S. Jones
Richard H. Randall
Michael J. Wilder

The Marine Laboratory
University of Guam
Agana, Guam 96910

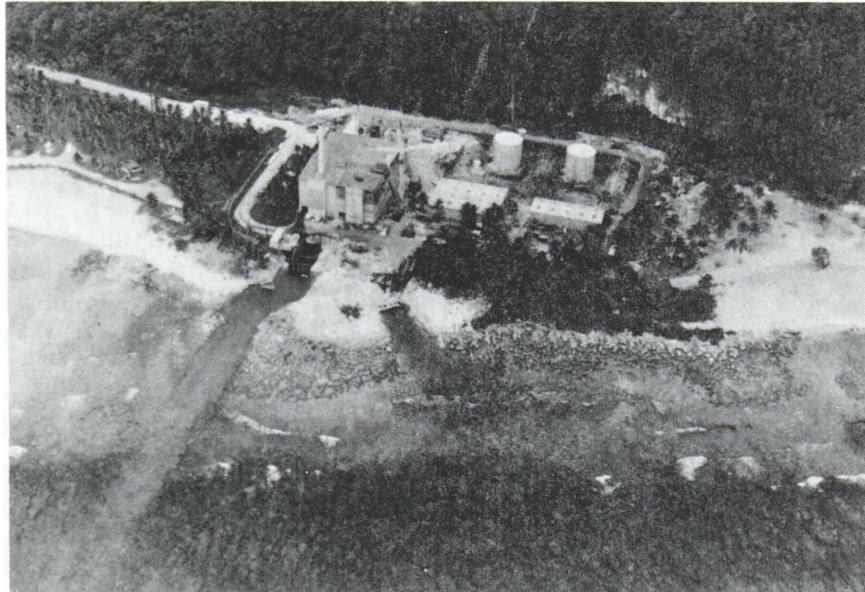
Figure 2 Aerial photograph of the Tanguisson Power Plant site

The Tanguisson Power Plant is located on an elevated terrace that is covered with beach deposits (Fig. 2). Vegetation around the plant is composed of an old coconut plantation and a well-developed strand vegetation along the beaches. This terrace is backed by steep limestone slopes and a cliff on the landward side. The cliff reaches heights of about 100 m. Both the slopes and cliff support dense limestone forest vegetation. To the south, the terrace narrows down and eventually disappears near Amantes Point (Fig. 3). To the north, the terrace includes the Naval Communications Station (NCS) swimming beach and then continues along the coast up to Tanguisson Point where it narrows to a thin strip. Immediately to the west is the first of the reef zones described below.

Intertidal (5 to 10 m wide)-- In most places the intertidal zone is either bare reef-rock, sand, or an irregular raised strip of solution-pitted limestone (Fig. 2).

- Figure 1. Location map of Guam showing study areas.
- Figure 2. Aerial photograph of Tanguisson No. 1 site. Tanguisson No. 2 is under construction directly adjacent to No. 1.

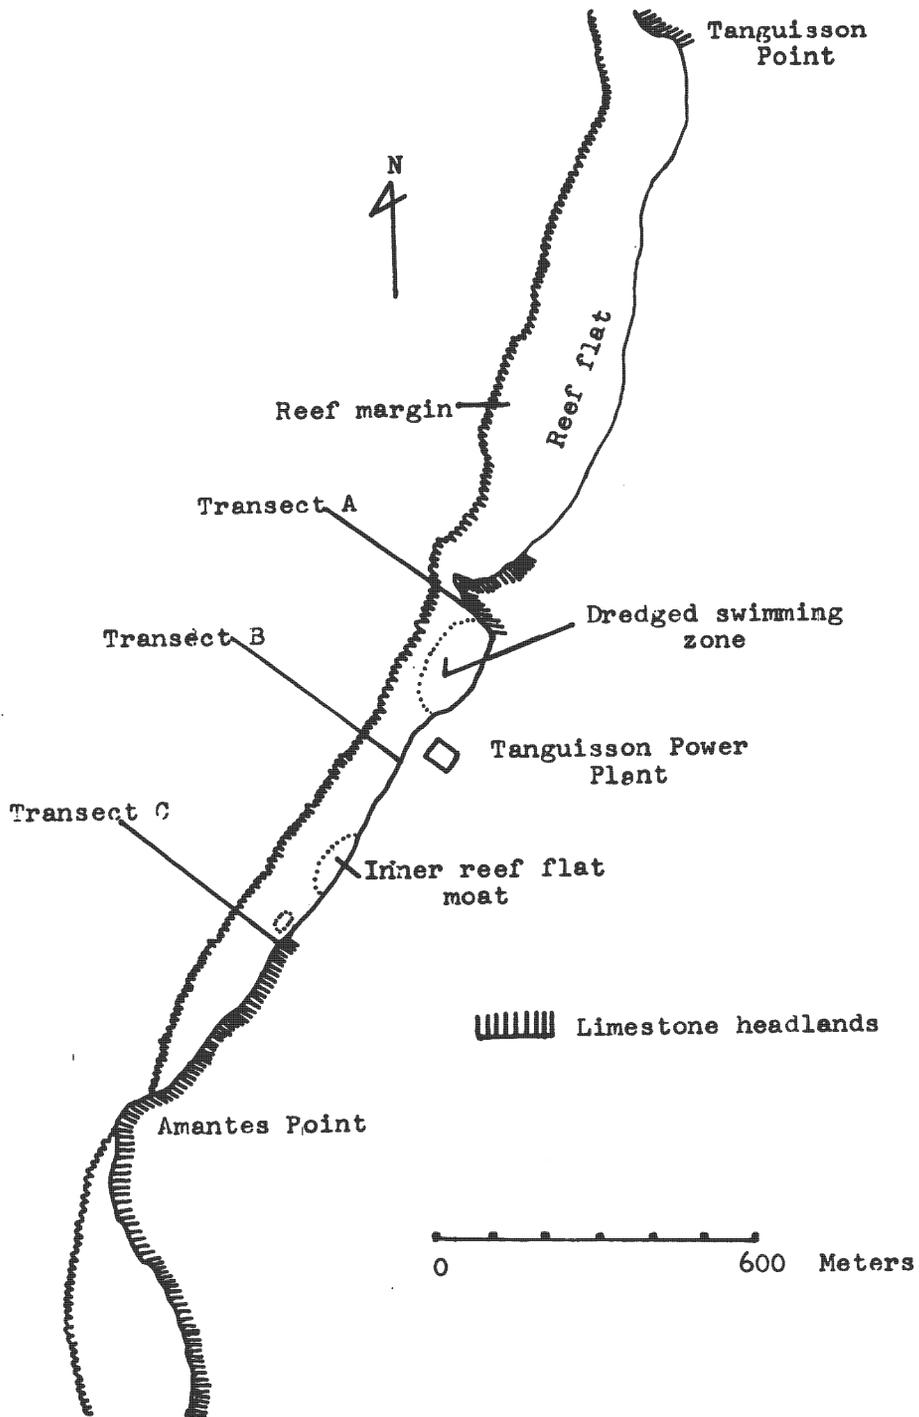
Figure 3 Detailed map of the Tanguisson Point study area showing transect locations

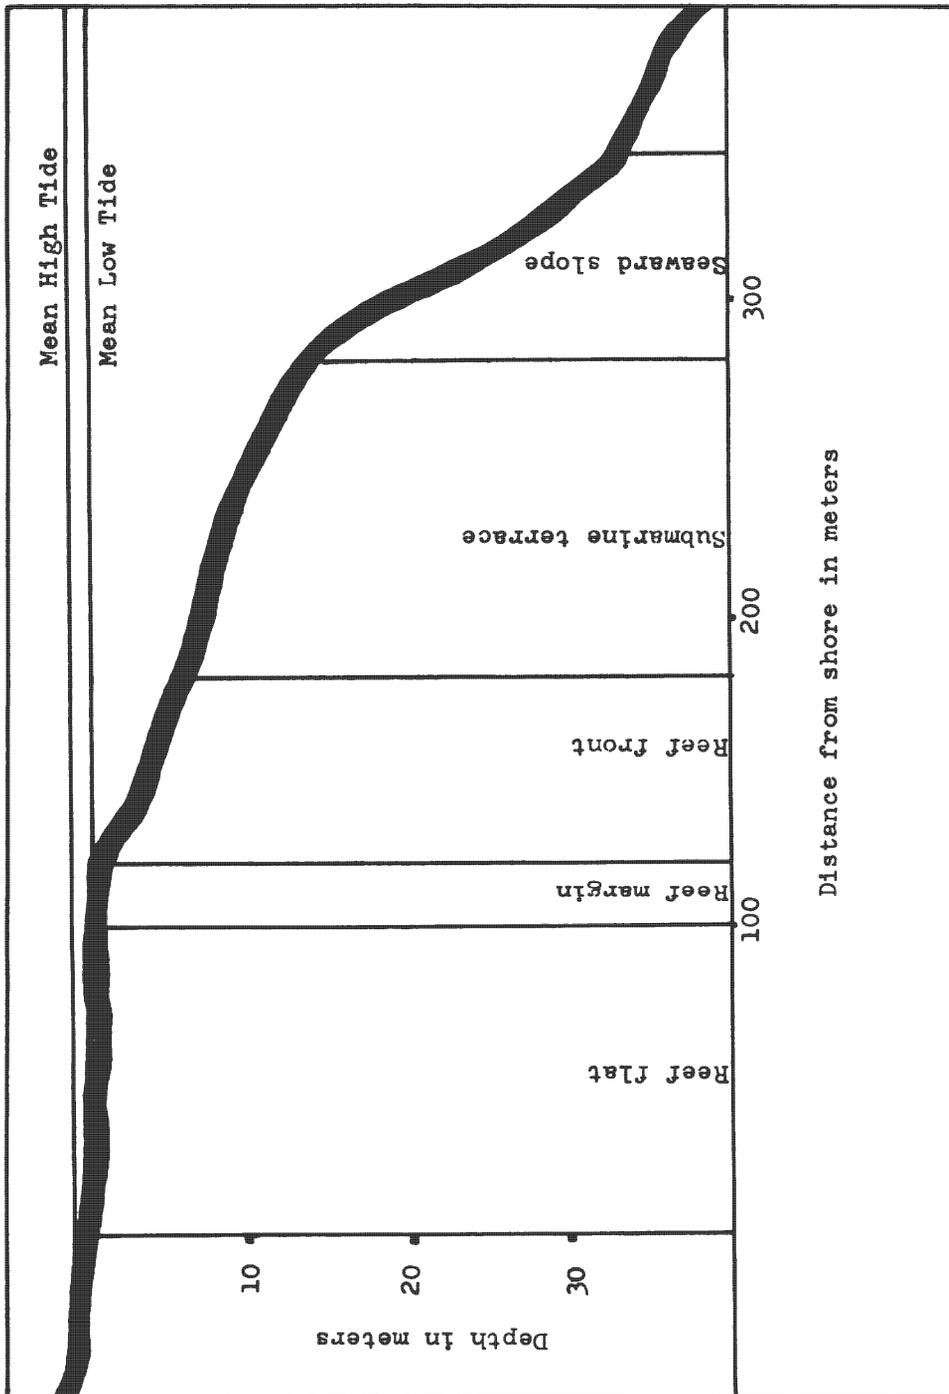
Figure 4 Reef profile at Transect B

Submarine Terrace -- The first submarine terrace represents a noticeably flattened region when compared to the reef front and seaward slope zones (Fig. 4). This zone ranges in width from 40 m at Transect C, to 110 m at Transect B. The shoreward margin of this zone begins at the 6 meter

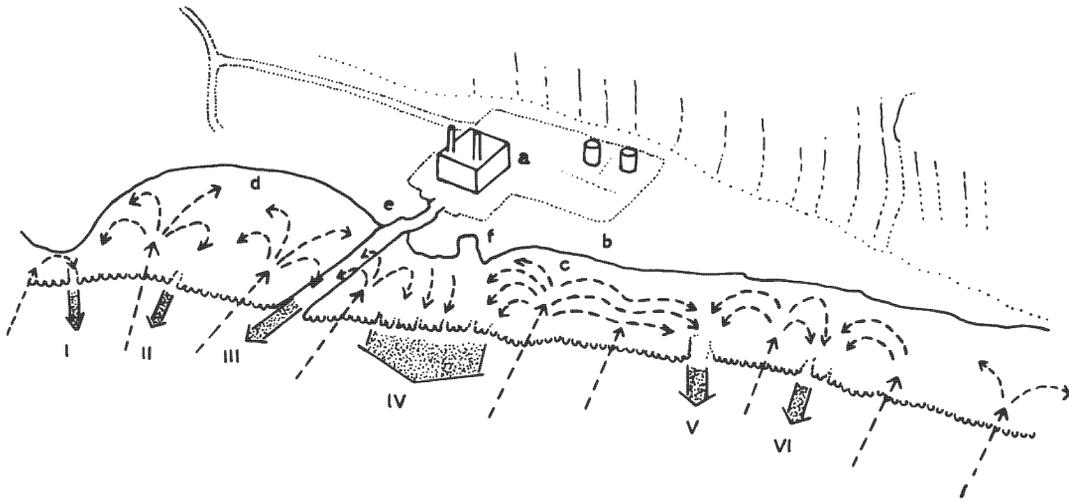
Figure 5 Current patterns on the reef flat prior to release of effluent

Except in the natural low areas north of Transect C (Fig. 5, V & VI), where there is a strong seaward rip current during high tides and surf, dye releases on the lower reef margin and upper reef front result in slowly spreading stains that move parallel to the surfline and in the direction of the prevailing current over the submarine terrace. A suspended particle would tend to be swept back and forth over the margin and upper front by wave surge and at the same time be carried slowly along shore because of the influence of offshore water movements. Such a particle describes a zigzag pattern. This type of movement results in considerable mixing due to wave attack. No changes in this pattern were observed after plant startup.

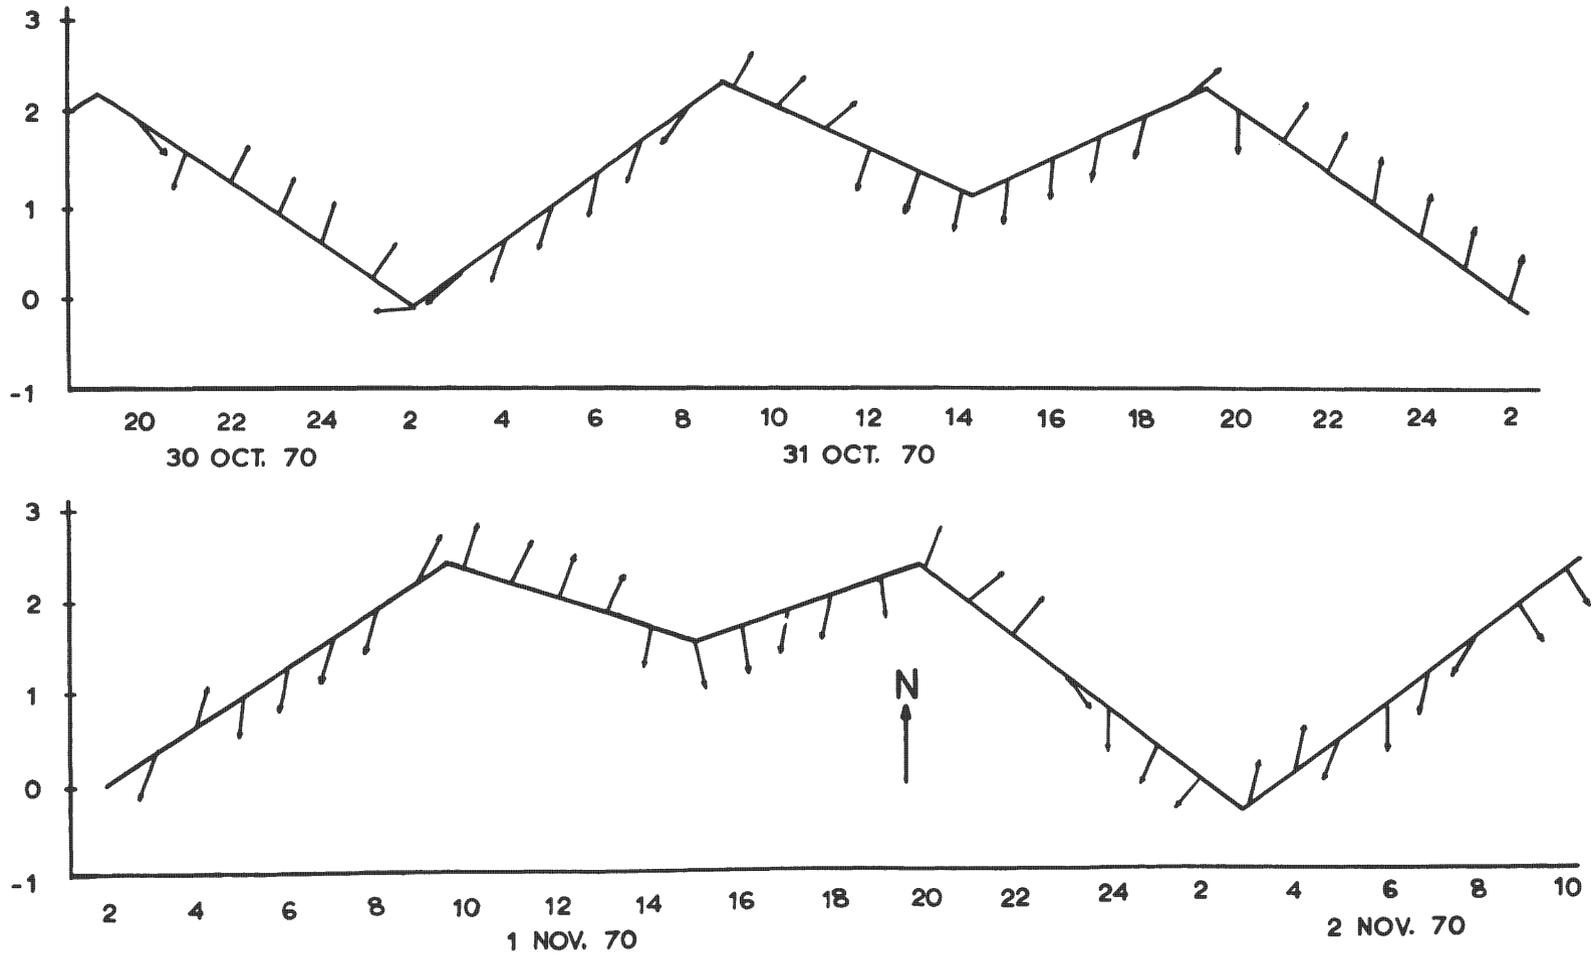
Figure 12 Sample segment from one current meter tape indicating a close fit between tide cycle and current direction

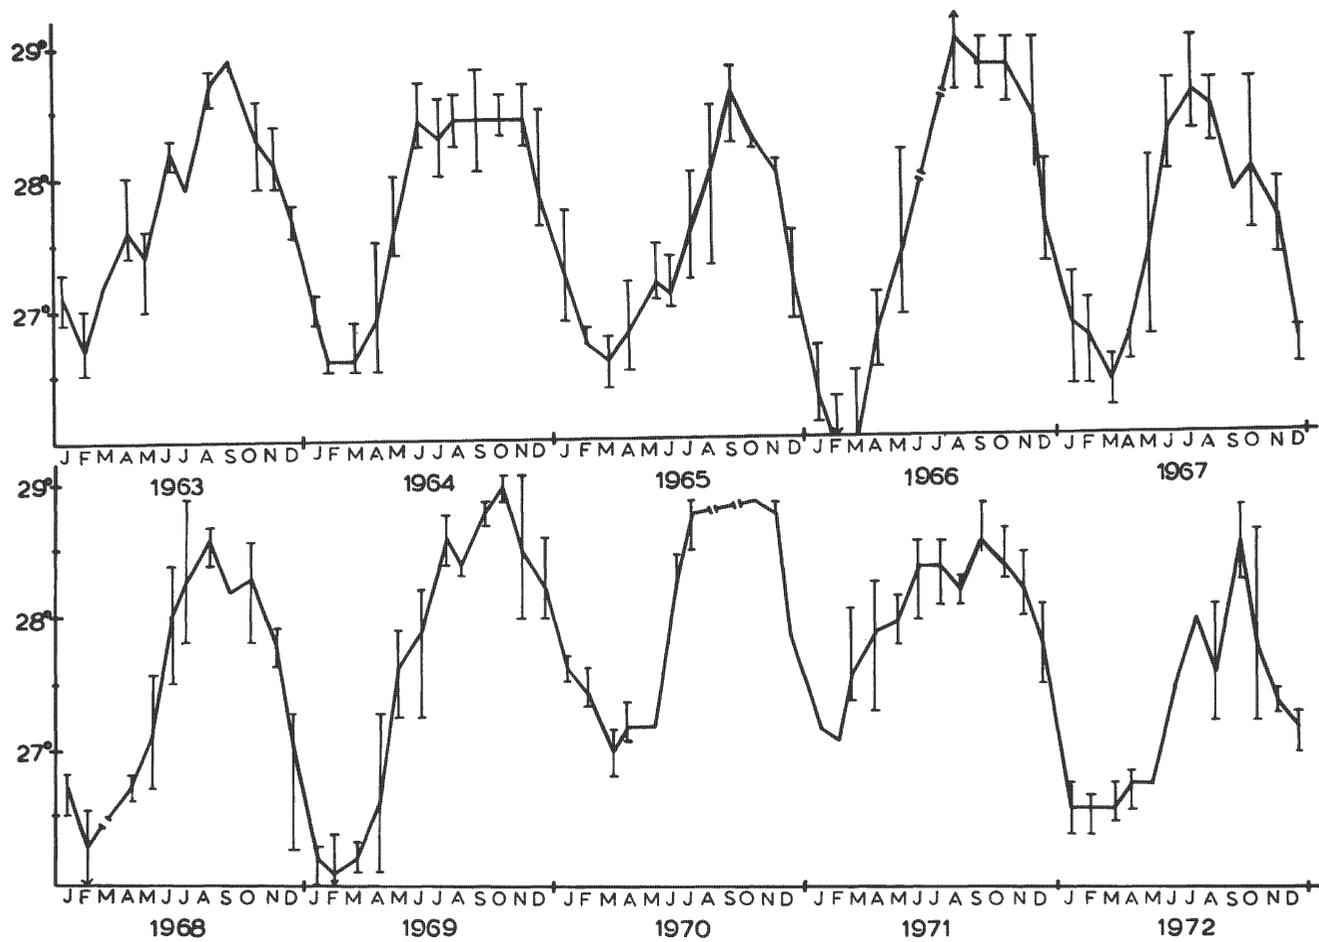
Figure 18 Plot of mean monthly sea surface temperatures for a 10 year period at Tanguisson Point

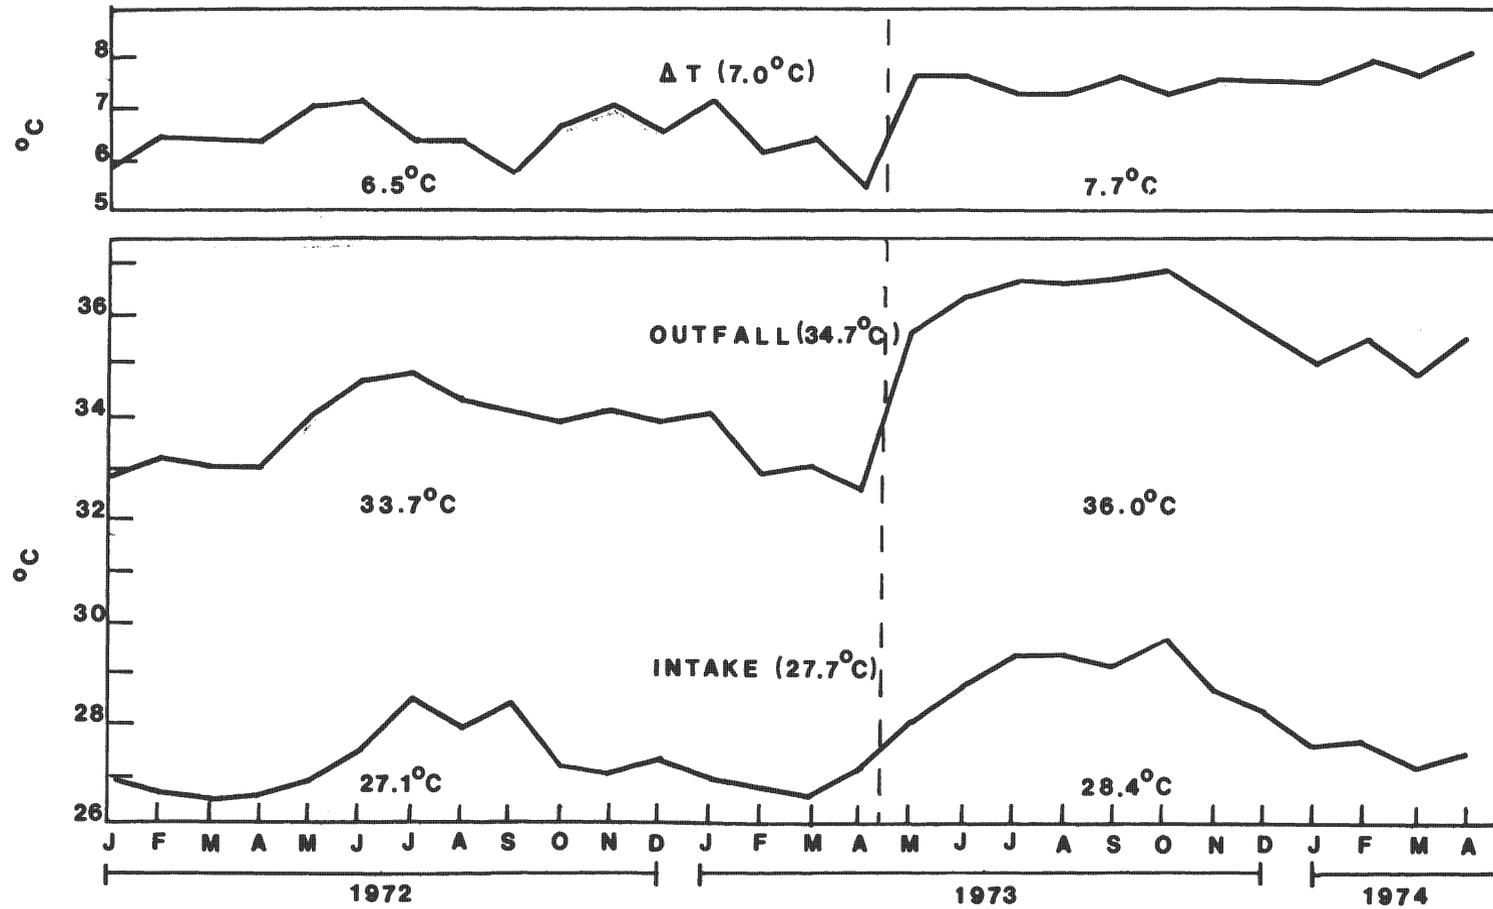
Figure 19 Power plant operating temperatures

After Tanguisson No. 1 began generating power, plant personnel provided valuable temperature readings from Control Room thermocouples. These data included intake and outfall temperatures for January 1972 through April 1974 (Fig. 19). Thermometer and thermograph readings were obtained several times from the intake channel and stilling well to verify these data. Tanguisson No. 1 began regular power production in January 1972 and was the only plant in operation during the first 16 months. Unit No. 2 was completed and began operations in May 1973. Both units operated together during most of the last 12 months of the field study (Fig. 19).

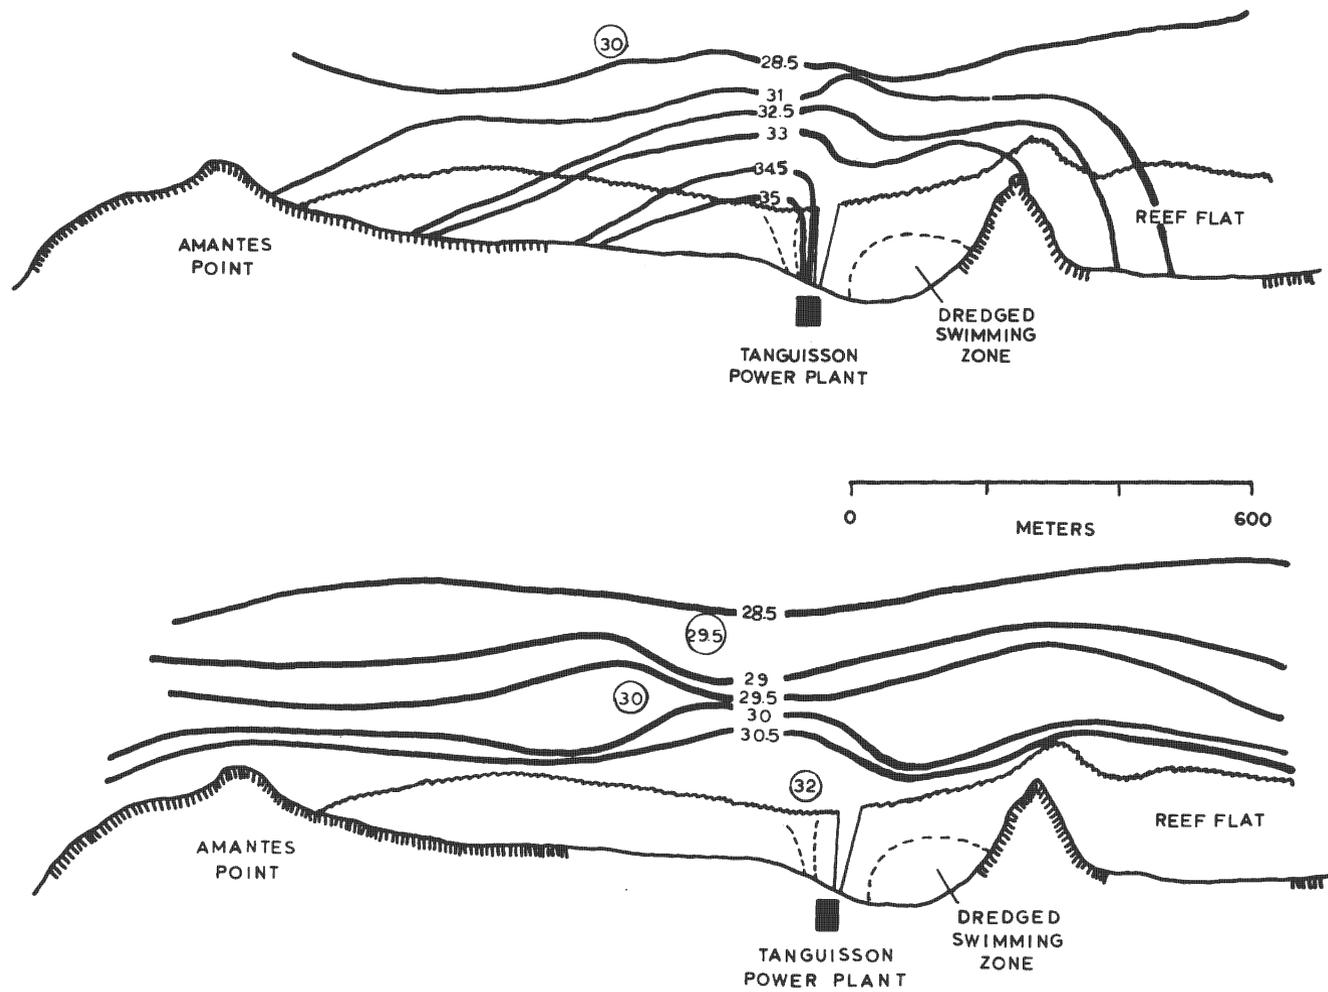
Figure 20 A, B. Surface and 1 m isotherms for August 2, 1974.

A somewhat different condition prevails when current flow and wave transport is reduced or absent. Four studies were made at such times between August and September 1974 (both units operating). The limits of the thermal plume were studied by establishing stations at 10 m intervals along temporary transect lines running at right angles to the reef margin. Transect B served as the control transect. Temperature profiles were made at the surface and 1 m depths (Figs. 20A-H). From the isotherms it is evident that the effluent spreads out in a seaward direction as expected. In most cases there is a difference in the distance out to ambient water reached by the surface and the 1 m profiles. This would seem to indicate rapid stratification of the effluent as it proceeds seaward. The seaward bulge that occurs in Figures 20E-G occurred during a flat calm sea with zero current offshore.

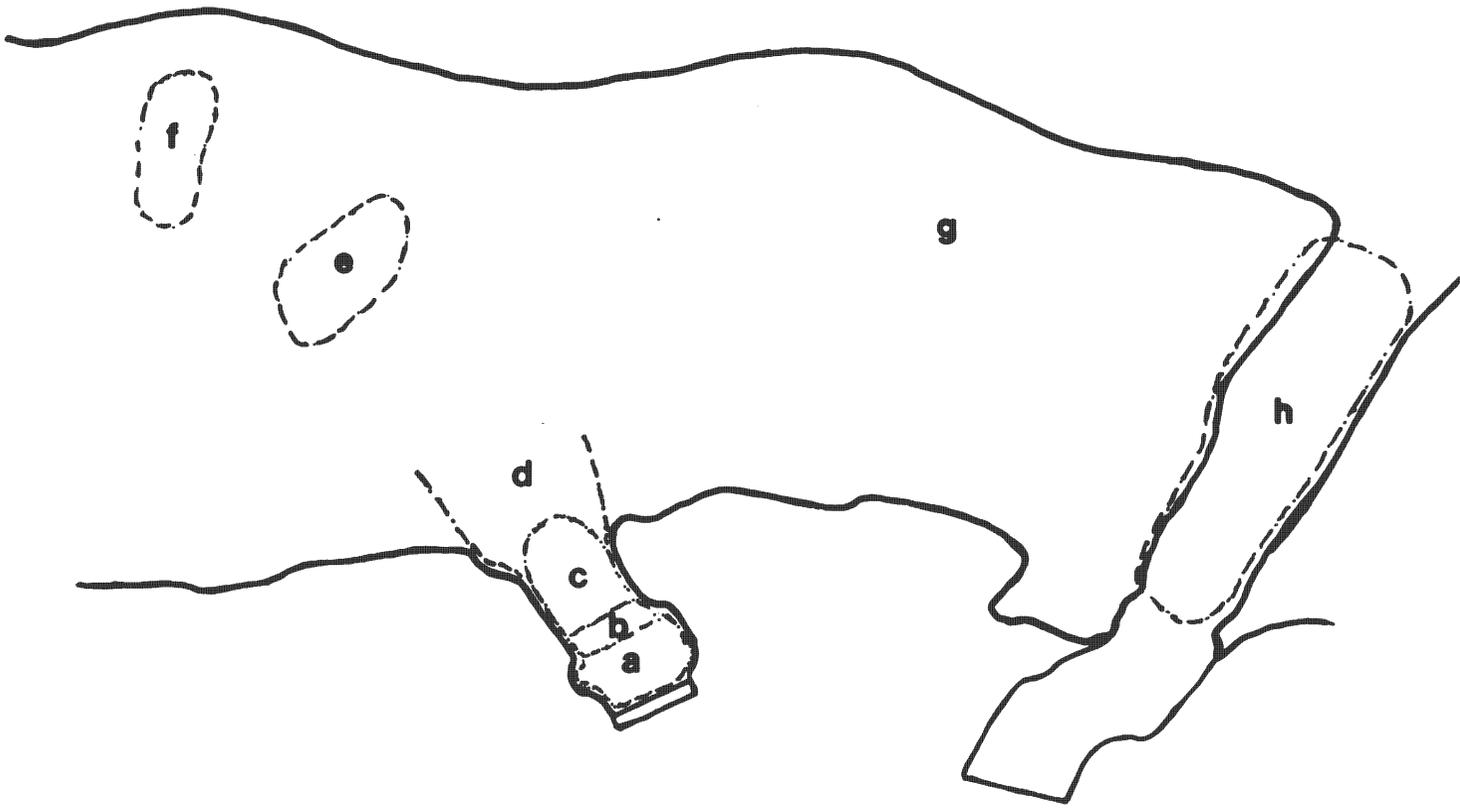
Figure 22 A. Algal community after thermal discharge.

the brown (Fig. 22A). Blue green algae were still present in the channel but were no longer dominant as they had been after the initial channel construction. Figure 22B shows that three of the intake channel species have disappeared and seven new species added since startup of Tanguisson No. 2. G. marginatus remains the dominant alga in the channel.

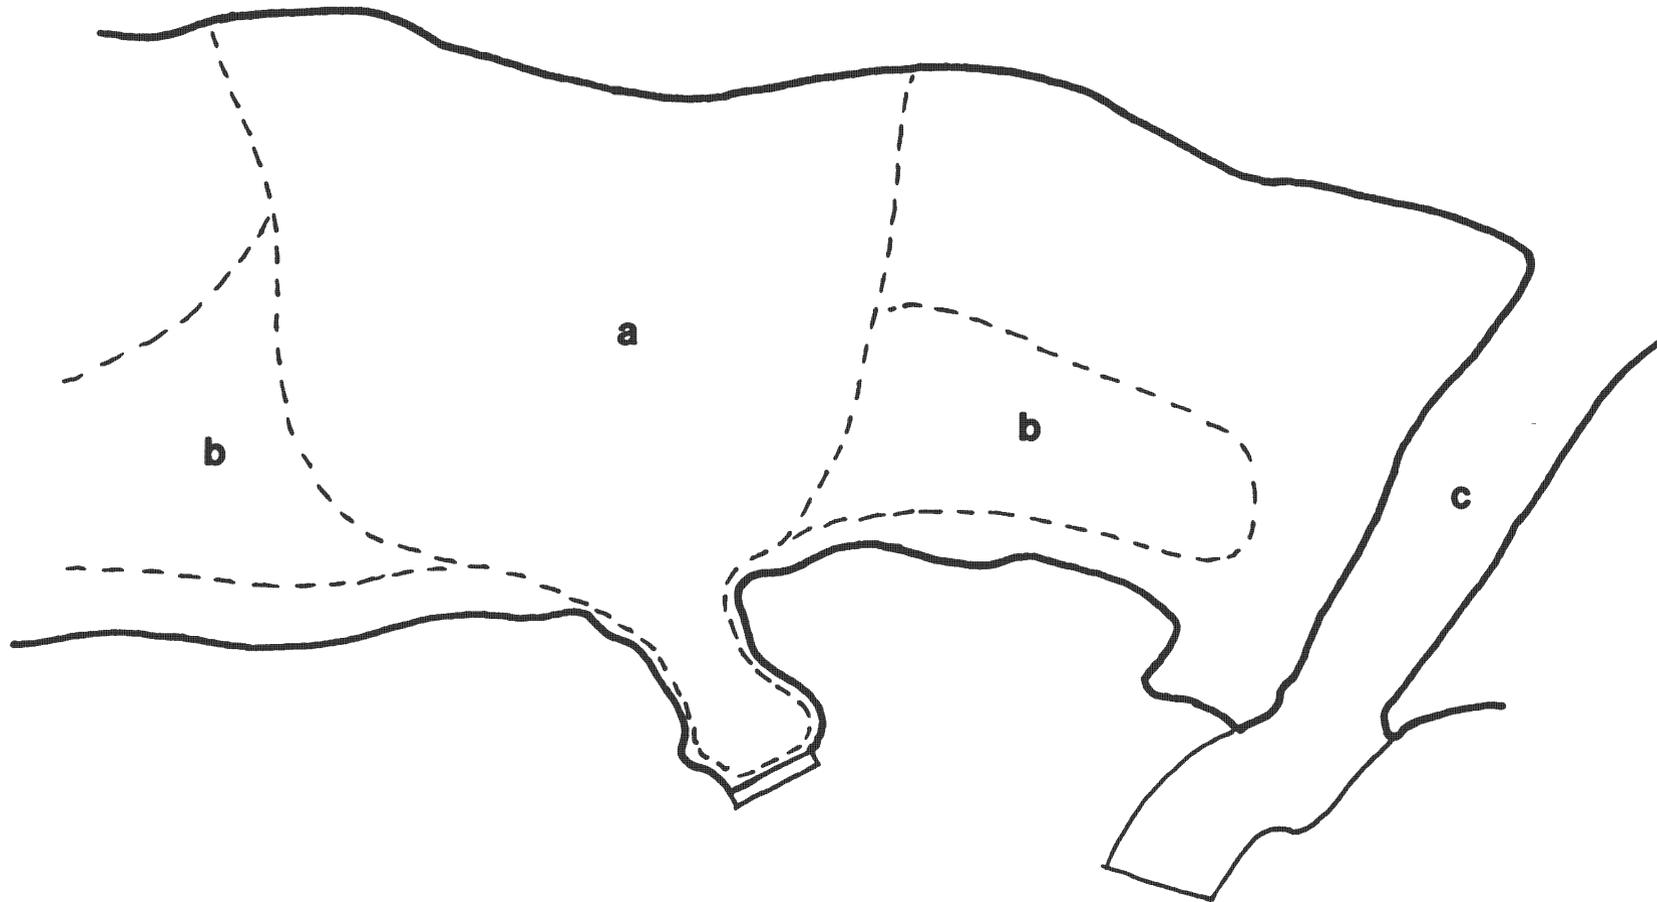
Figure 22 B. Algal community after thermal discharge of Tanguisson No. 1 and 2.

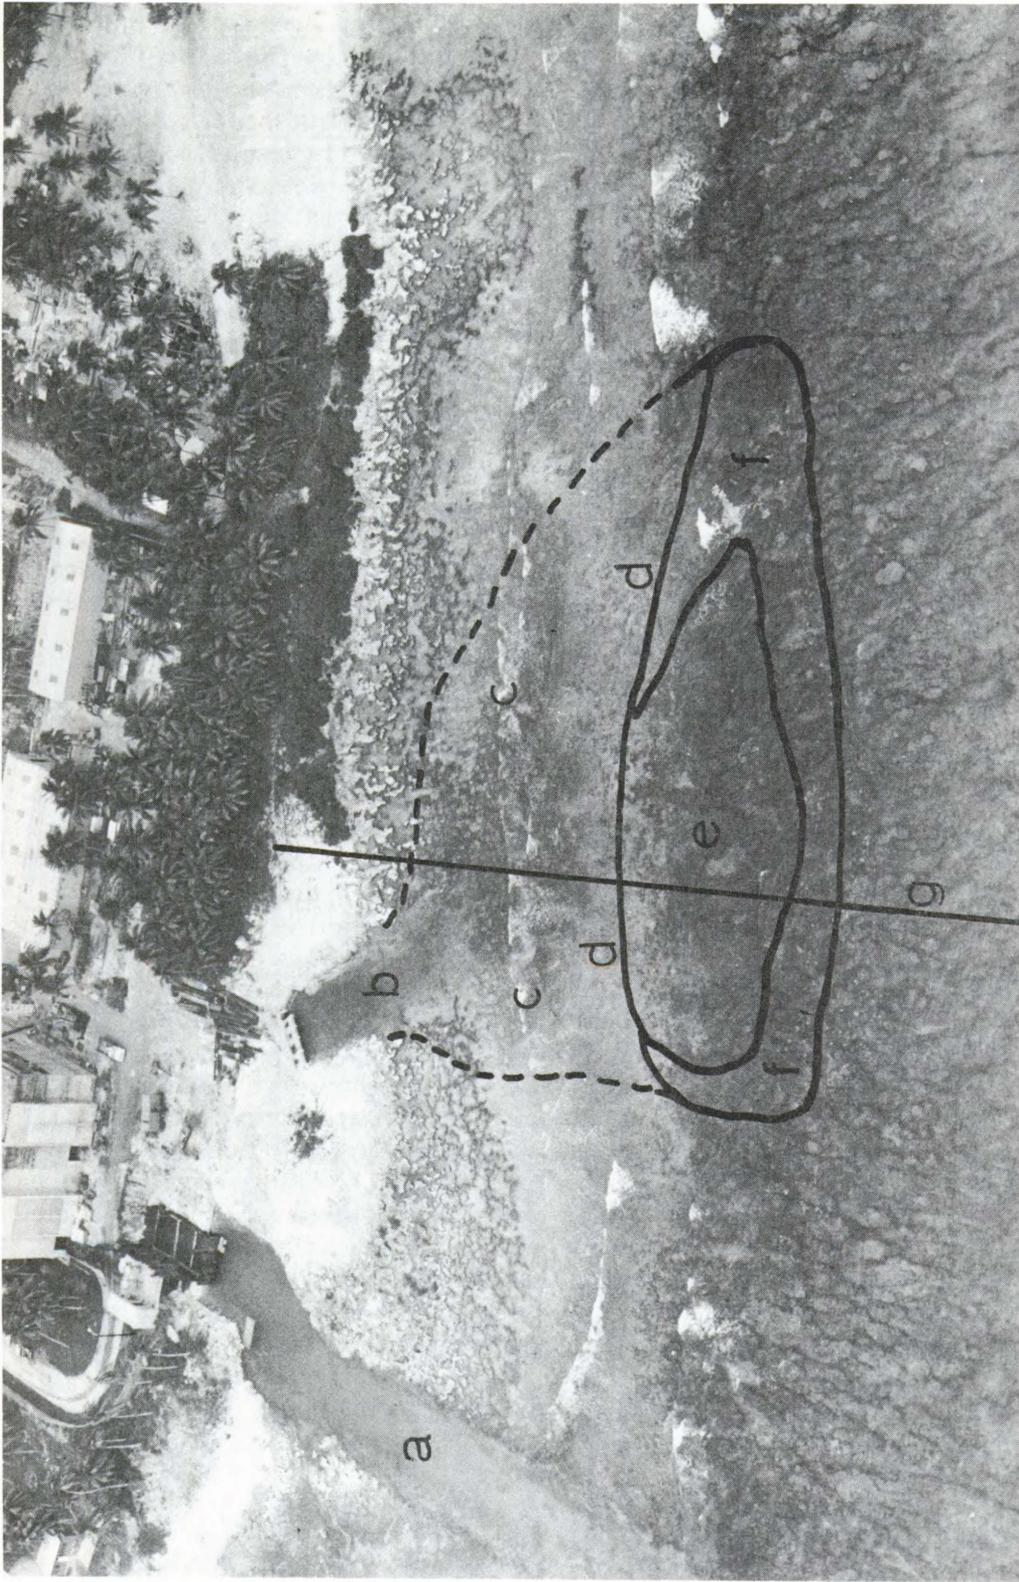
Figure 23 Limits of coral kill as of December, 1972

During the testing period, the first observation of a "coral-kill" in the outfall region was made (on December 27, 1971). At that time a two-man team was recovering thermographs from the reef margin on Transect B and noticed that numerous corals were of a pale or bleached-white color (Fig. 24-26). The results of a survey showed that the zone in which freshly killed corals were found was roughly limited to the region outlined in Figure 23. The boundaries of the coral-kill zone were not sharply defined except for a shoreward section located along the inner reef margin where the effluent first makes contact with living corals (Fig. 23d). In a peripheral zone (Fig. 23f) the corals killed were usually limited to the upper surfaces of submarine buttresses and the upper margins of the surge channels (Fig. 24 and 27). The coral species killed in the peripheral zone were presumably those with less thermal tolerance (Table 7). As the warmer area of the coral-kill zone (Fig. 23e, core zone) was approached, the density of bleached and freshly killed corals increased along with the number of species affected. In the core area itself the coral-kill was not limited to the upper regions of reef topographic features. It extended downward as well, along the walls of surge channels, submarine channels, and the floors of these two features (Figs. 25 and 27). Although heated outfall water has a tendency to float on the surface of the cooler ambient temperature seawater, data presented in the previous section on temperature indicates that wave and surf action mixes the effluent at the reef margin and inner part of the reef front zones (Fig. 27). This mixing action extends the vertical range in which corals are killed. Seaward of the surf zone the warmer water becomes stratified and is generally restricted to the upper one meter layer of water. It has little effect on living corals, since the water depth there is usually greater than one meter, except where the upper parts of corals knobs and knolls extend up into this one meter layer (Fig. 27).

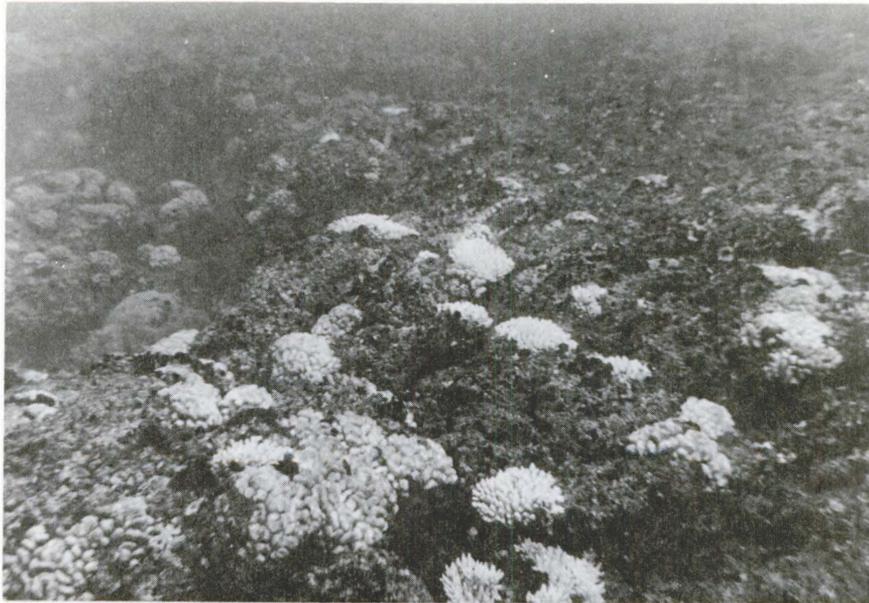
Figure 24 Coral kill on upper surface of a reef margin buttress

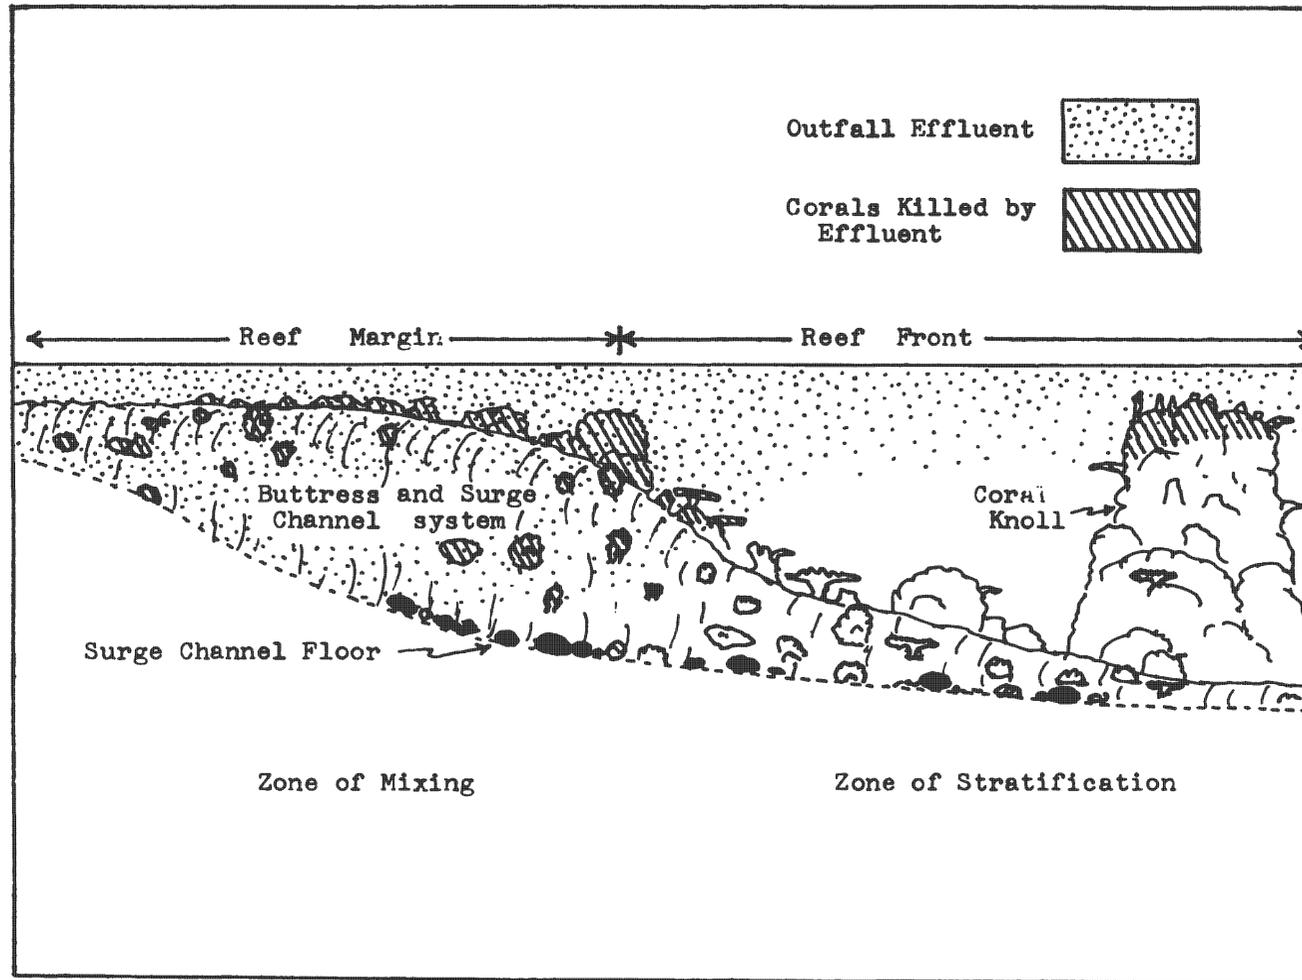
Figure 27 Vertical profile through the reef margin and reef front zones

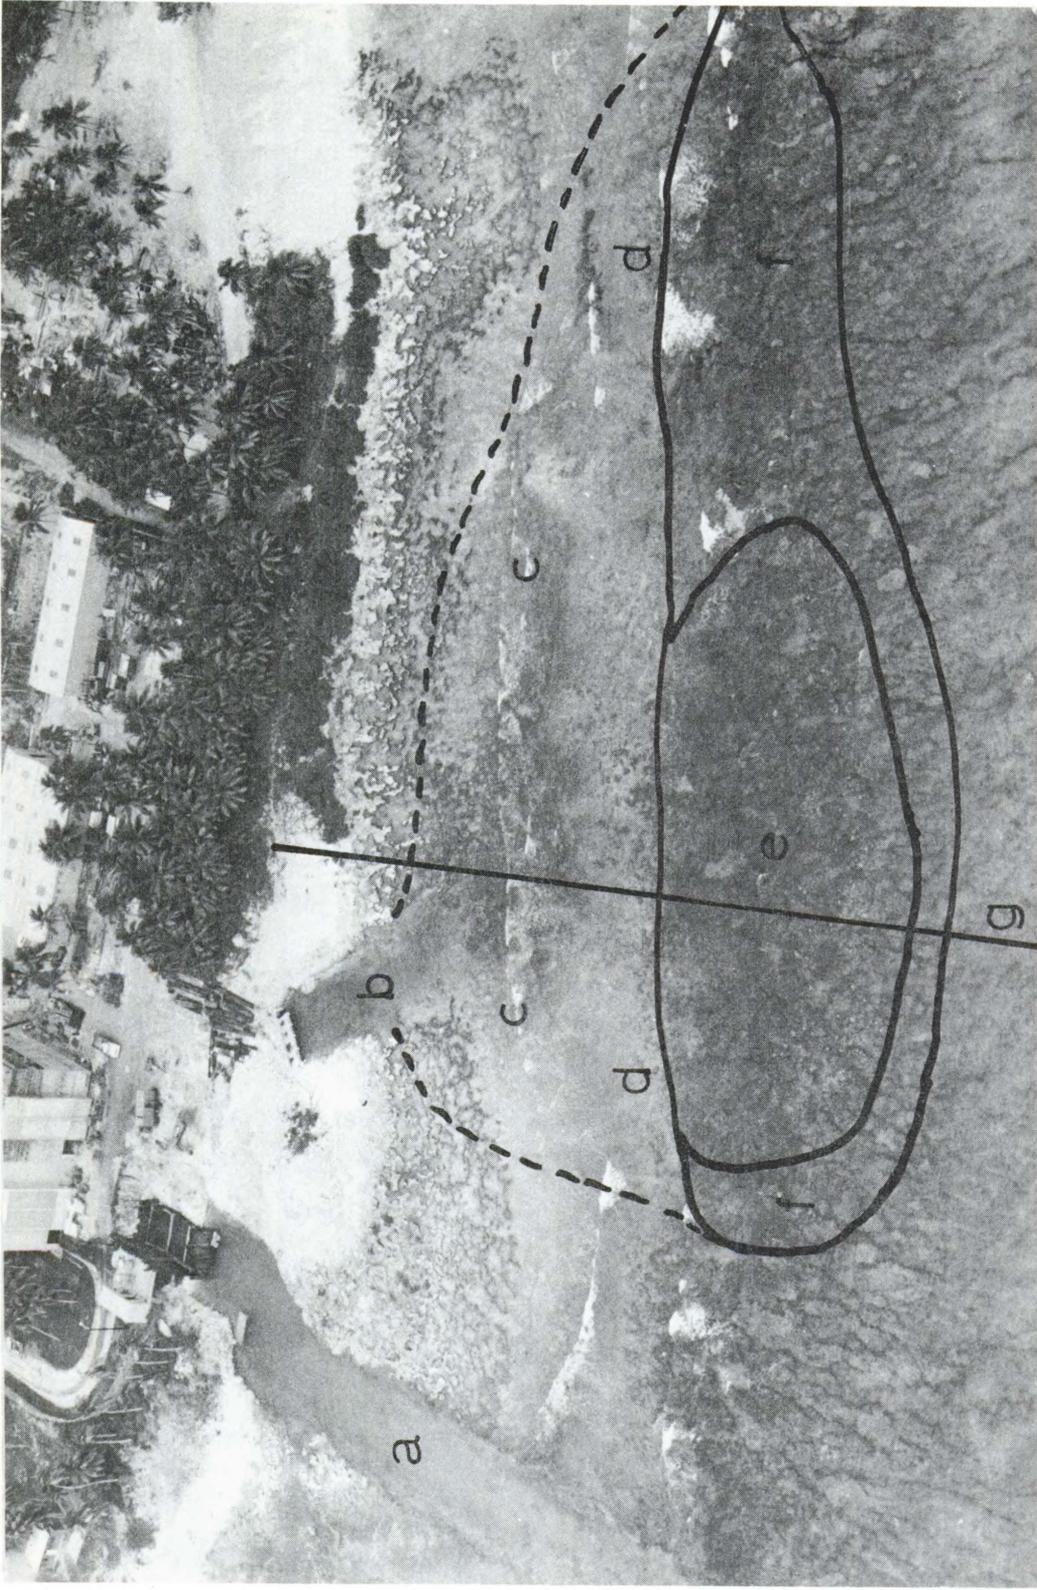
Figure 28 Limits of coral kill as of January, 1973

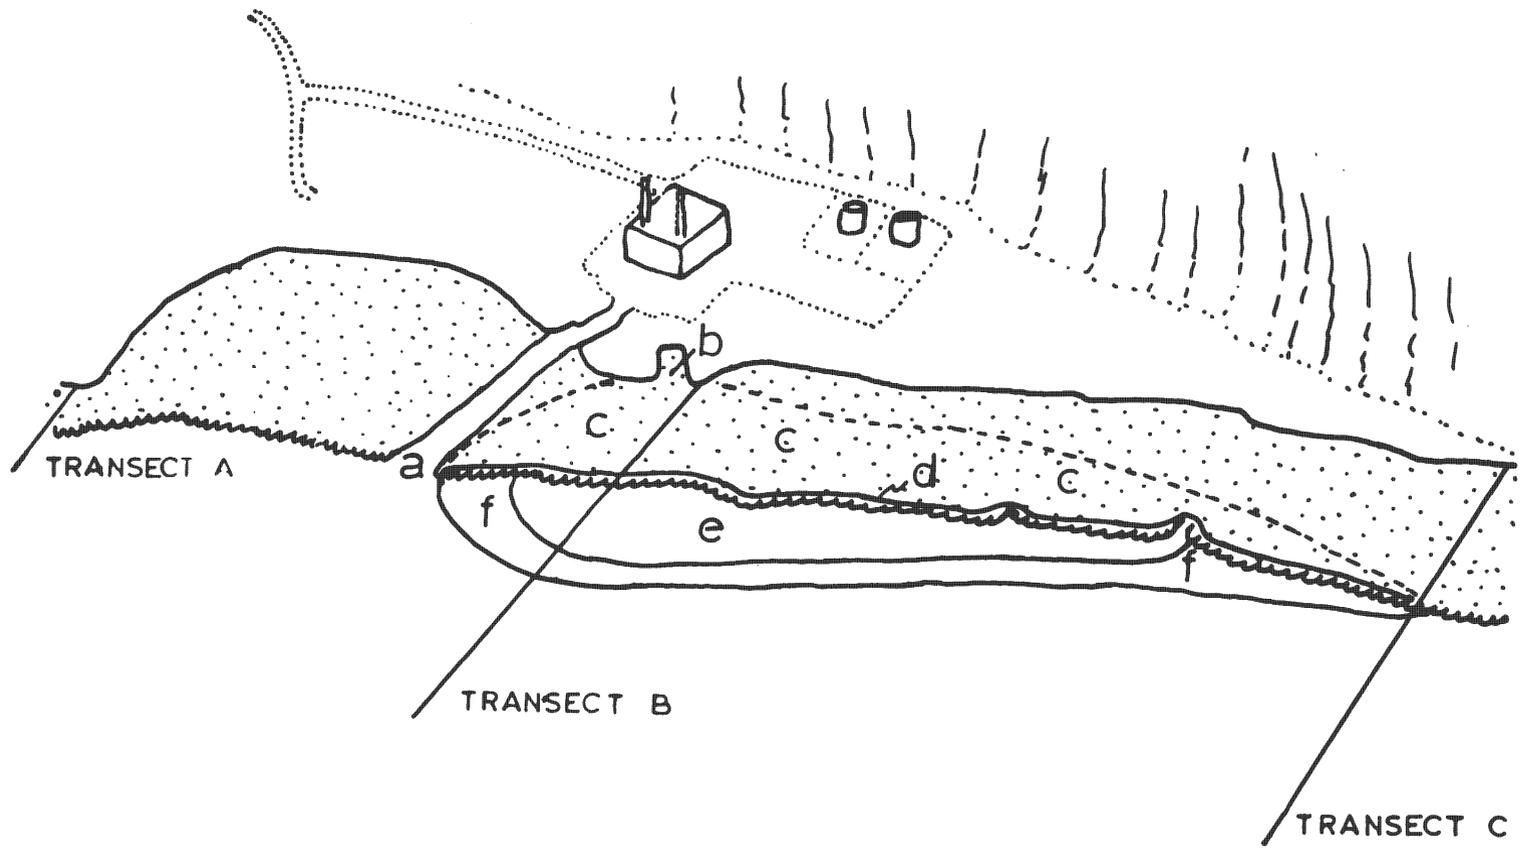
Figure 29 Limits of coral kill as of October, 1974

The damage reported above was caused primarily by the discharge of effluent from Tanguisson Unit No. 1. Now that Tanguisson Unit No. 2 is in operation, along with Unit No. 1, the volume discharge has doubled over the adjacent fringing reef community. This increased discharge was expected to affect a greater area of the reef community than that which was previously affected with only one generating unit in operation. The extent of the coral-kill area (core and peripheral zones) was again assessed in October, 1974, with both power plant units in operation.

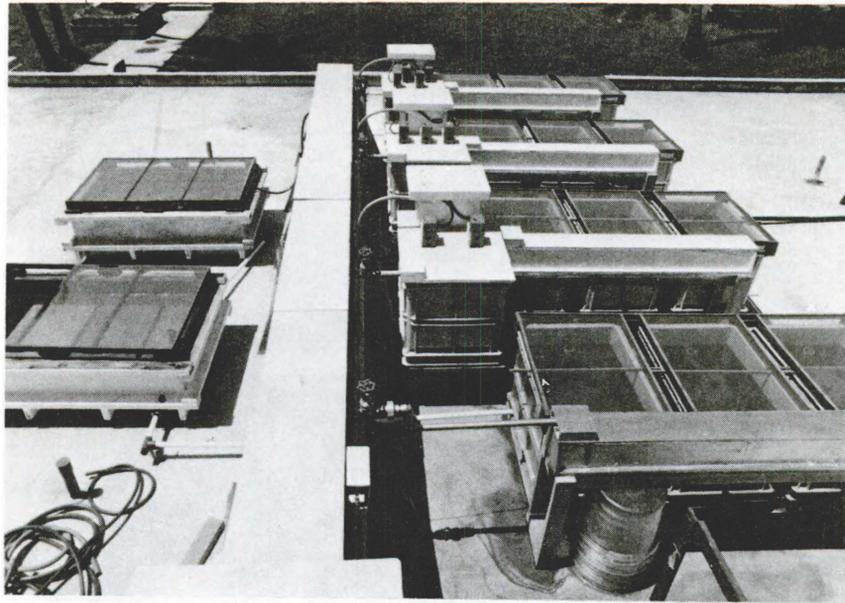
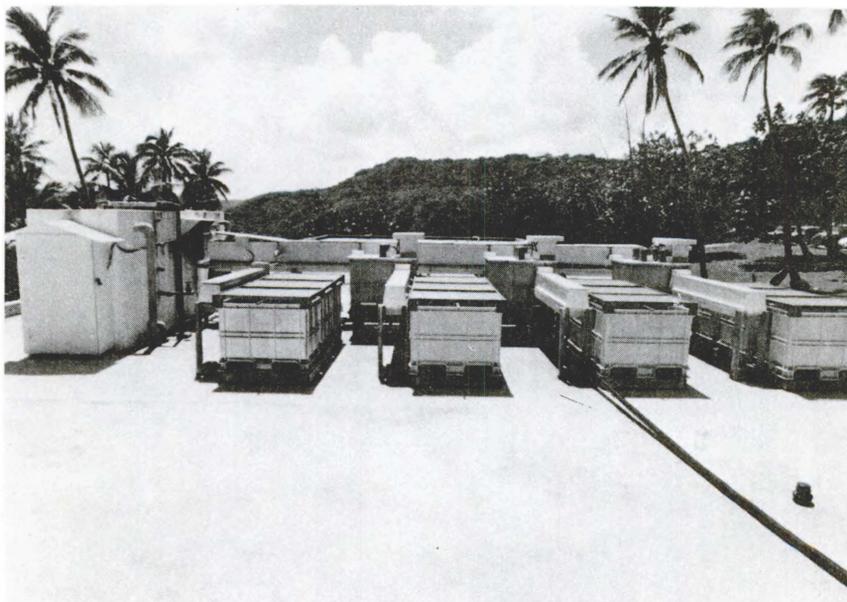
Figure 30 Thermal simulation device

Corals were acclimated for one to two weeks prior to introduction to the simulator (Fig. 31). The corals were placed in pans of fresh seawater and floated in the experimental tanks until they reached the experimental temperature (two to three hours). They were then arranged in rows within the tanks. The tanks were set up in replicates of three for each experimental temperature (Fig. 30). The rows of coral specimens were alternated between tanks to avoid bias in placement. Coralla were placed on inverted specimen jars to prevent bacterial contamination that often

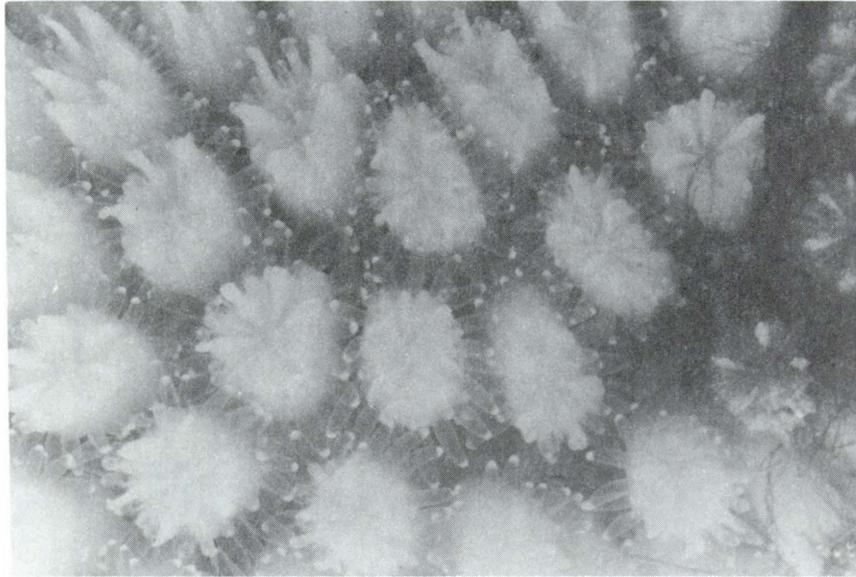
Figure 50 Bleached polyps of Galaxea hexagonalis

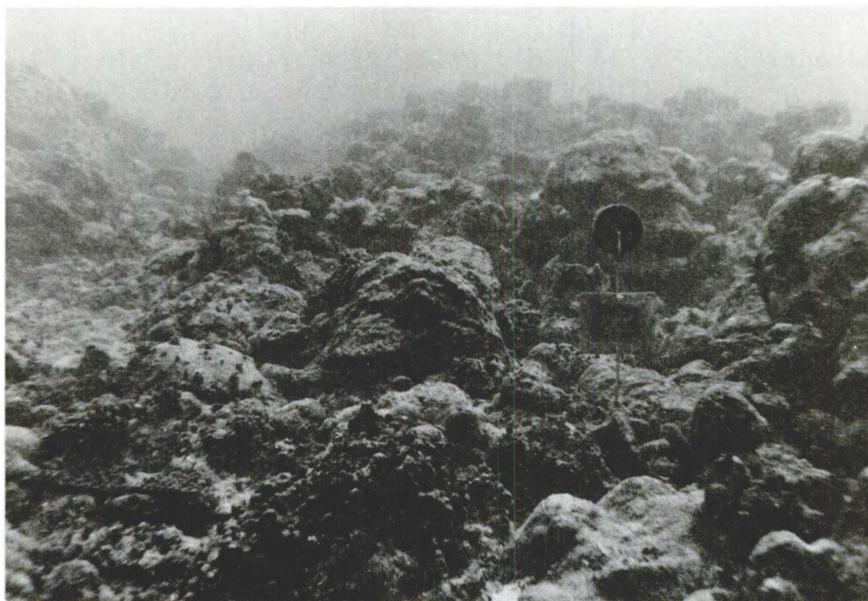
Figure 51 Transect B station showing anchor links and station number suspended by a float

Submarine Terrace Zone (40 to 110 m wide) and Seaward Slope Zone (50 to 70 m wide) -- The submarine terrace and seaward slope zones were the most heavily infested with A. planci during the initial invasion, and as a result nearly all the original coral populations were killed (Figs. 51 and 57). Regeneration of small sections of larger colonies and resettlement of some corals had taken place as described for the reef front, but to a lesser degree, especially on the seaward slope.
