EPA-600/3-76-027

BIOLOGICAL IMPACT CAUSED BY CHANGES ON A TROPICAL REEF

Robert S. Jones
Richard H. Randall
Michael J. Wilder

The Marine Laboratory
University of Guam
Agana, Guam 96910

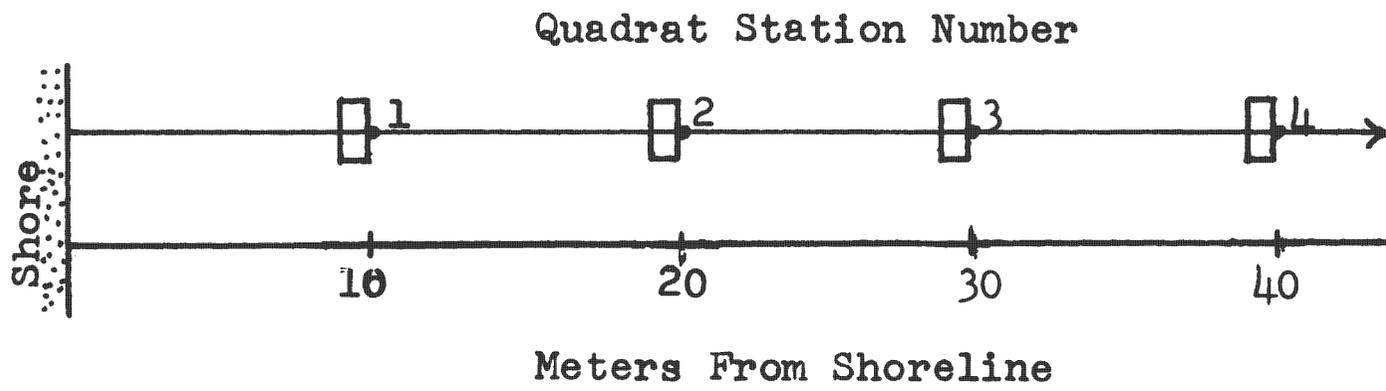
Figure 52 Diagram of the station quadrat transect method

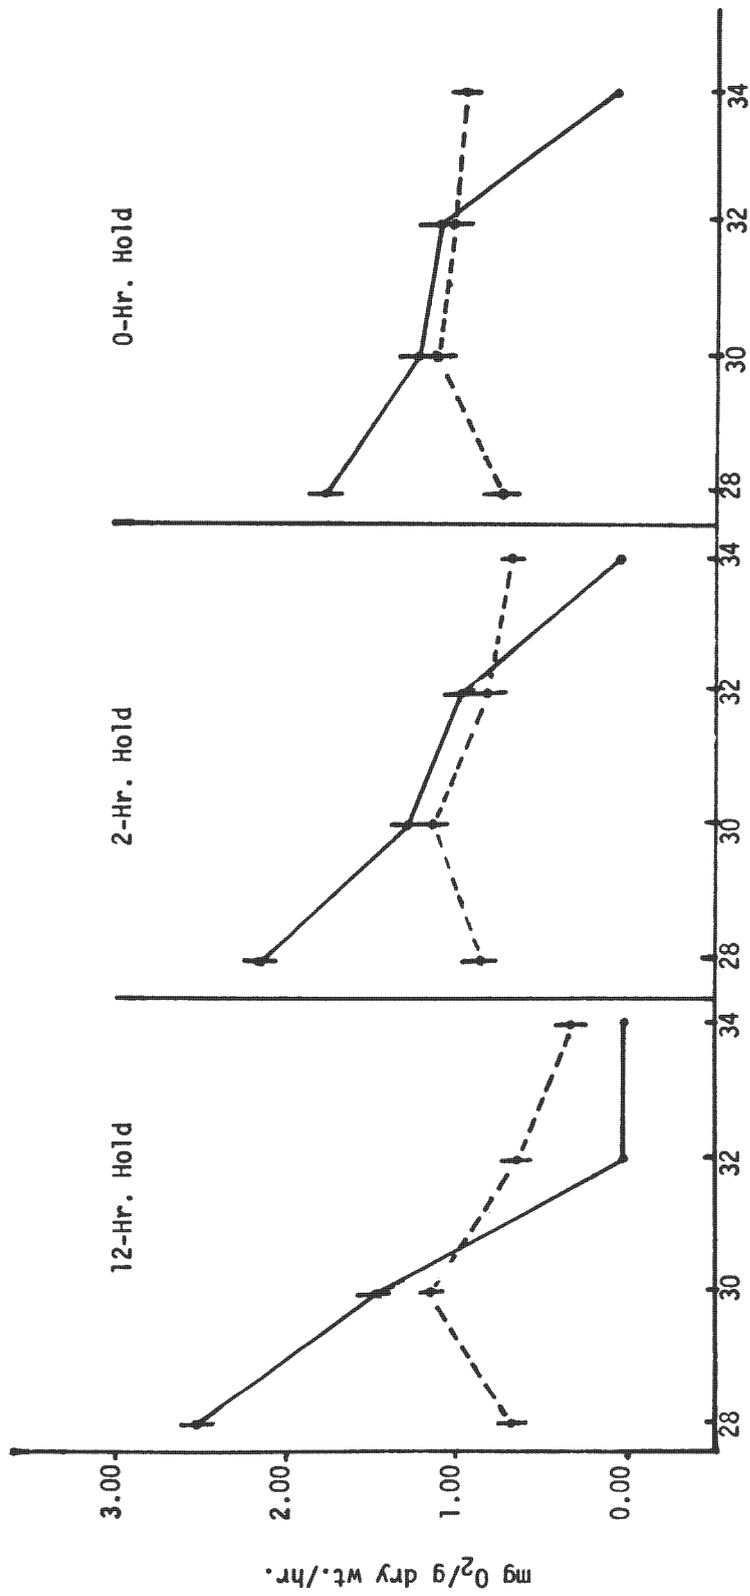
Figure C-1. Net photosynthesis and respiration values.

The respiration rates of Caulerpa racemosa demonstrate a sharp increase

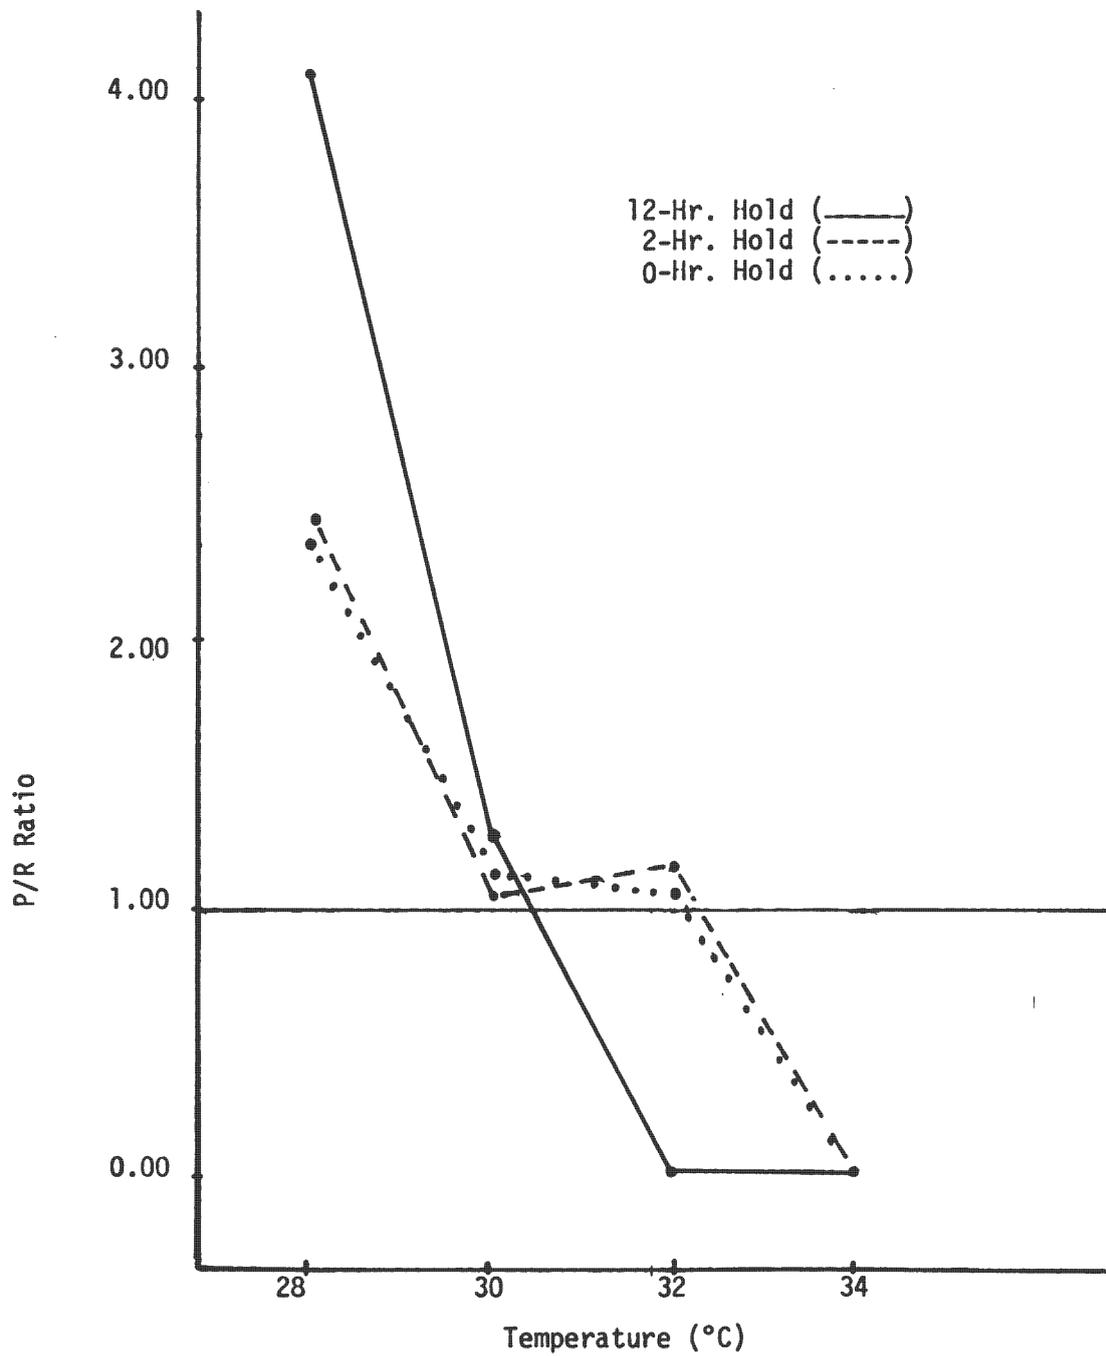
Figure C-2. Net photosynthesis/respiration ratio

This preliminary study on Caulerpa racemosa indicates that the P/R ratio may be used to quantify thermal stress or even death in marine algae. It is anticipated that these studies will be extended to include those blue-green algae which inhabit thermal effluent areas near power plants.
